APPRAISING MATERIALS AND THEIR REMEDIAL MEASURES FOR THE PRESERVATION OF HERITAGE ASSEMBLIES

Keywords: *Preservation, Ancient construction, Historic materials, Deterioration, Environmental loads, advanced engineering techniques.*

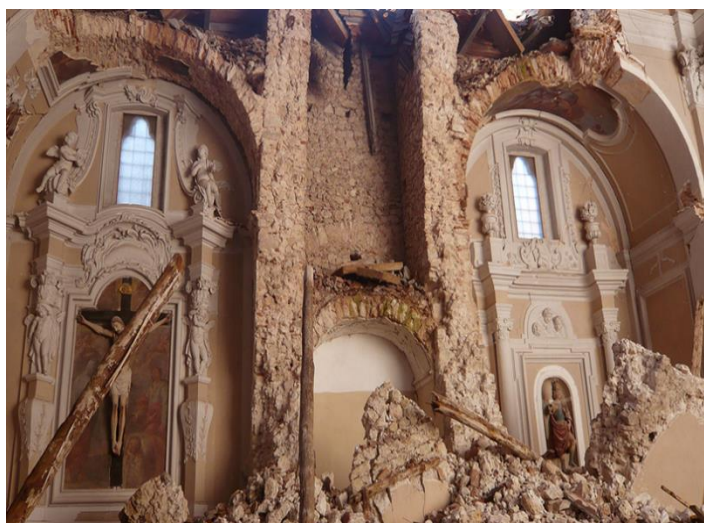
Figure 3 Material evaluation and remedial measures. *Source: WHC, ICOMOS.*

Following are some special materials, methods, and techniques that can be used for the preservation of heritage assemblies, damaged structural fragments, and protective coatings using appropriate repair remedies (Carter and Grimwade 1997),(Lakhani and Sharma 2018)

- A. Preservation treatments by materials
- B. Cleaning and Biocide treatments
- C. Repair: Reinstitution of damaged fragments
- D. Rebuilding: Renewal of completely damaged fragments
- E. Strengthening: Adoption and addition of structural fragments
- F. Mortar repair and Consolidating treatments
- G. Patching Materials and protective coatings
- H. Reinforcement materials
- I. Grouting Materials

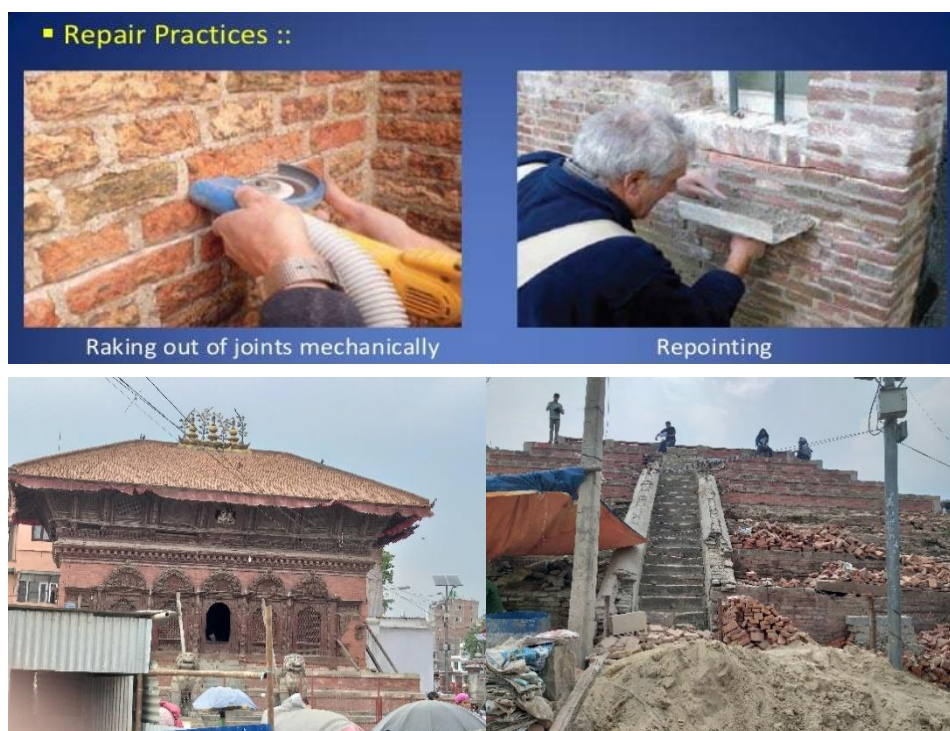
Figure 7 Image showing repair remedial practices over heritage assemblies Source: Photographs clicked by authors during the site survey, Nepal.

Synthetic and epoxy resins are extensively used during preservation treatments, especially for stone consolidation and protection. This is because they are less prone to physical, chemical, mechanical, and biological deterioration. Hence, the demand for preservative material is swiftly rising due to its excellent chemical resistance, mechanical strength, and effortless working (Selwitz 1992). For heritage assemblies, resins are used as a very good grouting material for injection in wood, brick, concrete, and metal as an adhesive coating for high performance when compared to cement grouting Figure 7.
